Technical Report HL-90-2  
September 1997

# Red River Waterway, Lock and Dam No. 4

## Report 2 Navigation Alignment Conditions

### Hydraulic Model Investigation

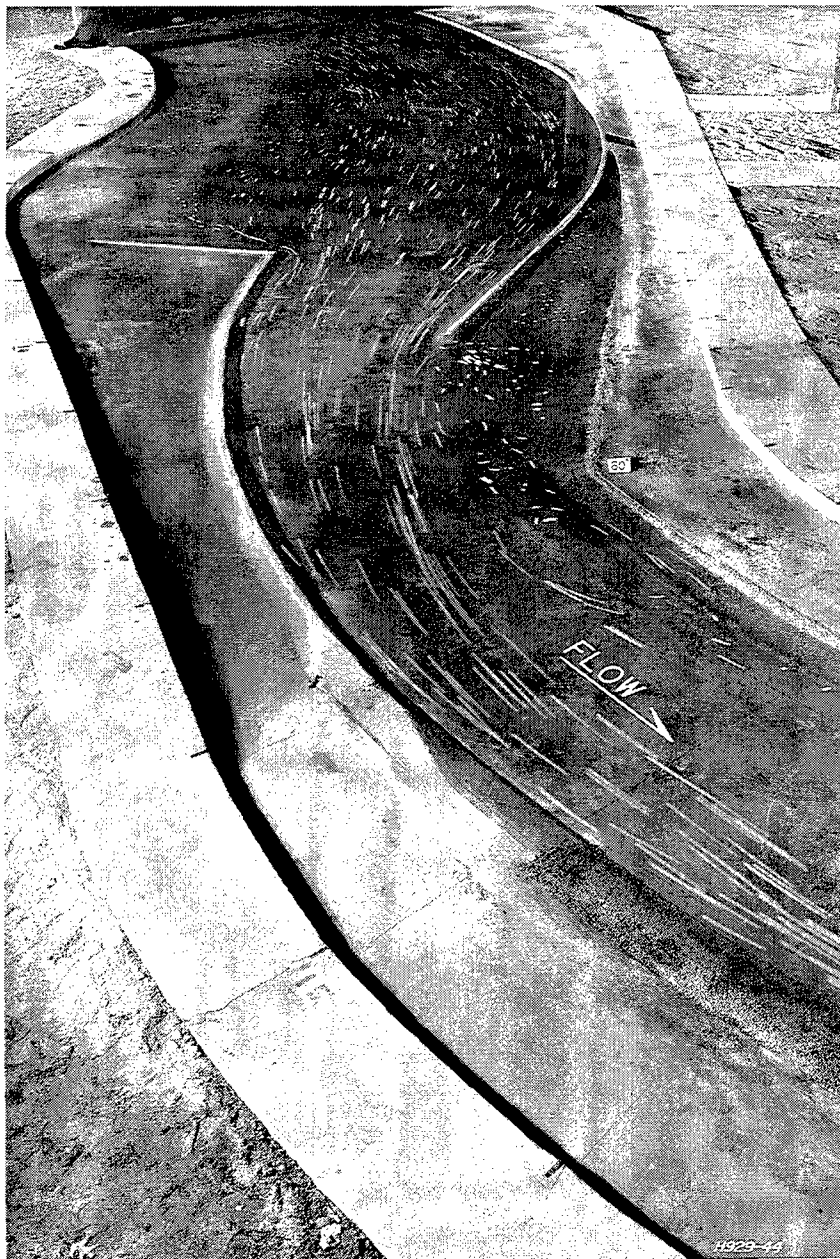
Photo 1. Plan B, looking upstream, discharge 60,000 cfs. Confetti showing surface current patterns entering and through Piermont cutoff

Current direction and velocity data, shown in Plates 1-5, indicate a concentration of flow through the constriction formed by the convergence of the stone-fill dikes at the upstream entrance to Piermont cutoff (Photo 1). The

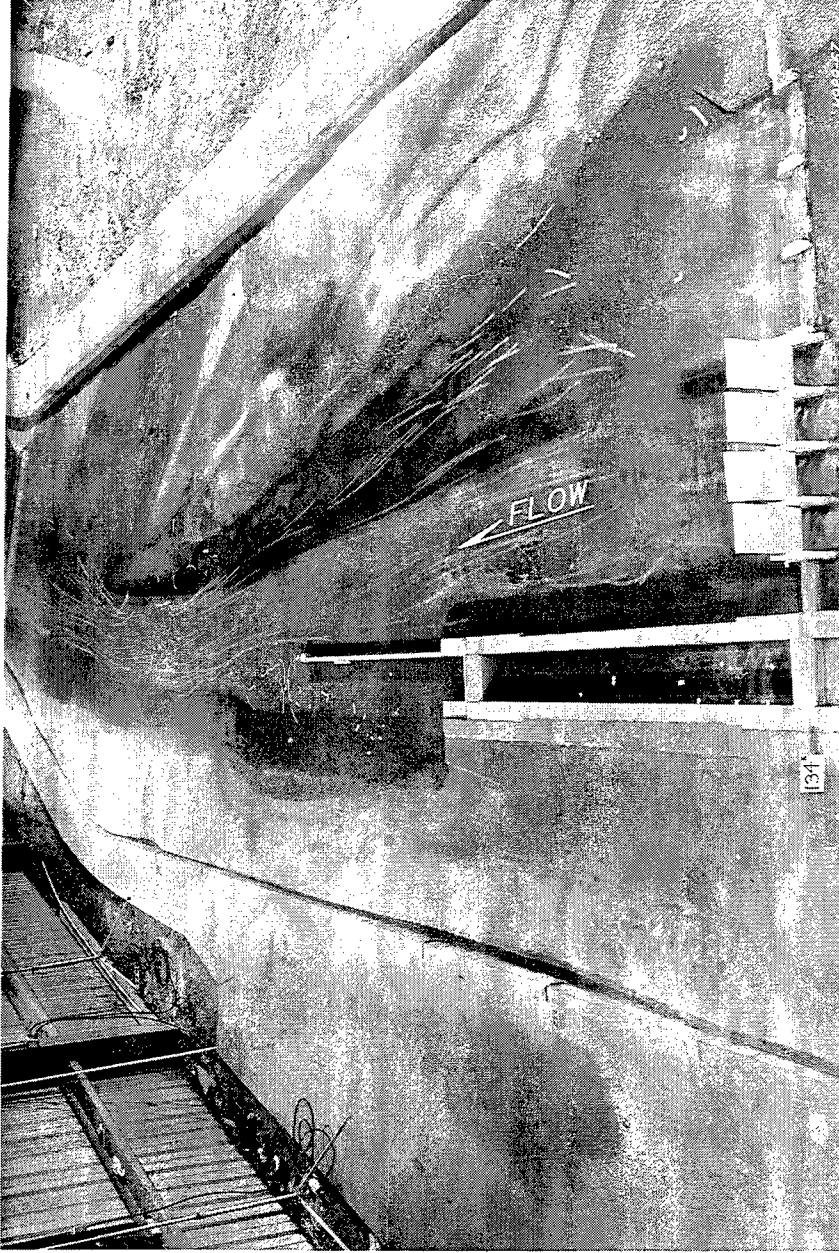
Photo 3. Plan B, looking downstream, discharge 134,000 cfs. Confetti showing surface current patterns in the lower lock approach

Currents downstream of the dam were directed toward the left descending bank, across the lower lock approach, where the flow then crossed the main channel toward the right bank in the direction of the old river channel (Photo 3). The maximum current velocity across the lower lock approach downstream of the lower guard wall ranged from 5.5 to 10.1 fps with riverflows of 20,000 and 80,000 cfs, respectively. A counterclockwise eddy was observed in the lower lock approach with upstream velocities ranging from 1.0 to 5.2 fps with riverflows of 20,000 and 80,000 cfs, respectively. The maximum current velocities recorded in the lower pool generally occurred in the vicinity of the lower guard wall with maximum velocities ranging from 6.1 to 14.9 fps with riverflows of 20,000 and 134,000 cfs, respectively. The velocity of the currents across the lower lock approach and the size of the eddy decreased in magnitude somewhat with riverflows above 80,000 cfs due to the increase in flow area.

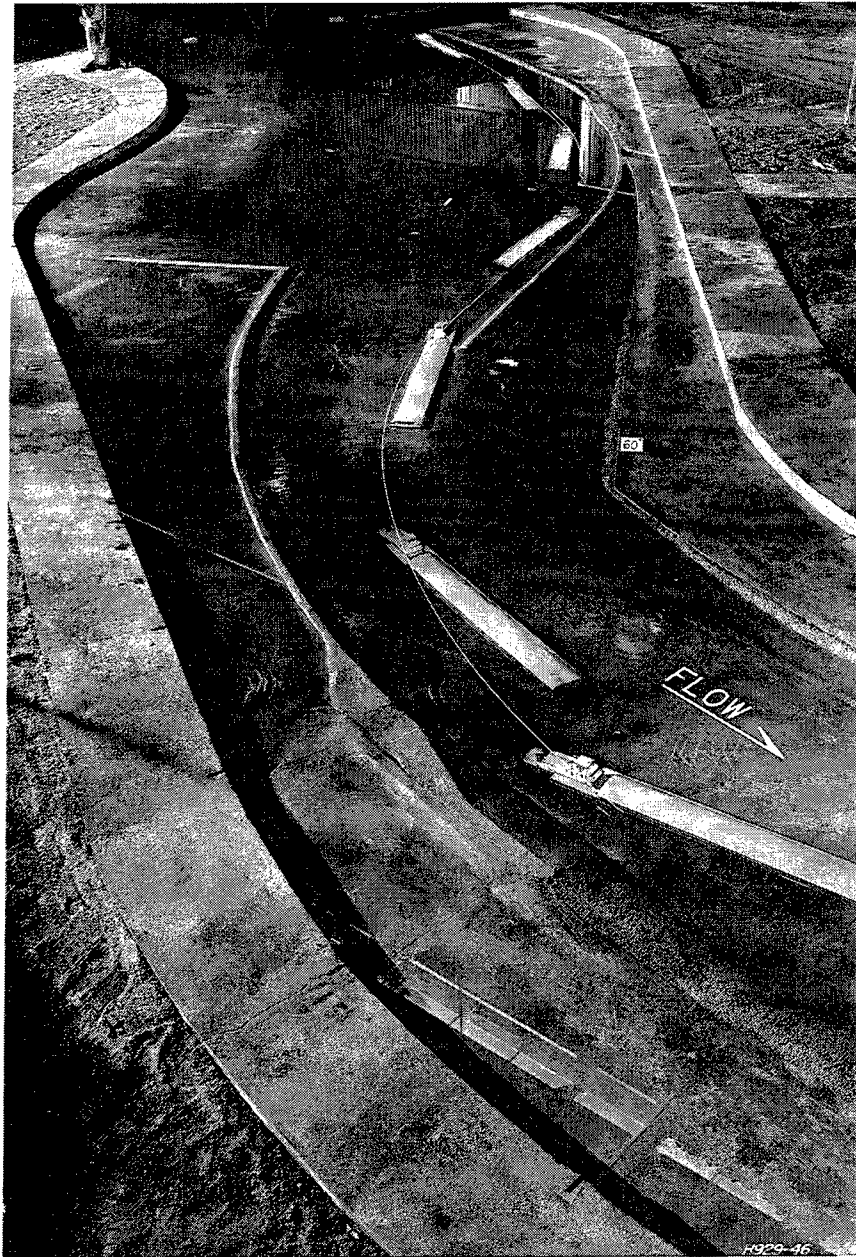
Photo 4. Plan B, looking upstream, discharge 60,000 cfs. Path of down-bound tow entering Piermont cutoff. Note tendency for tow to be confined against right descending bank

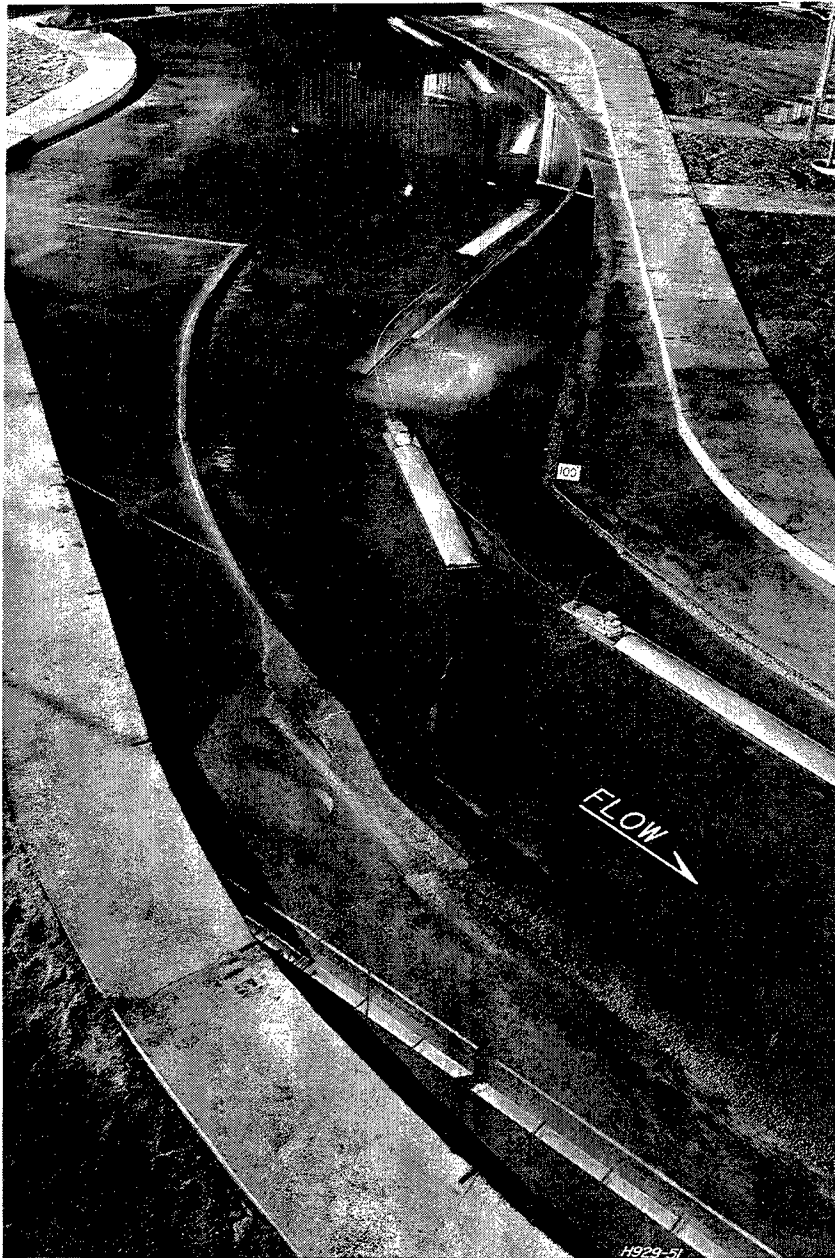
Photo 5. Plan B, looking upstream, discharge 100,000 cfs. Path of down-bound tow flanking into Piermont cutoff

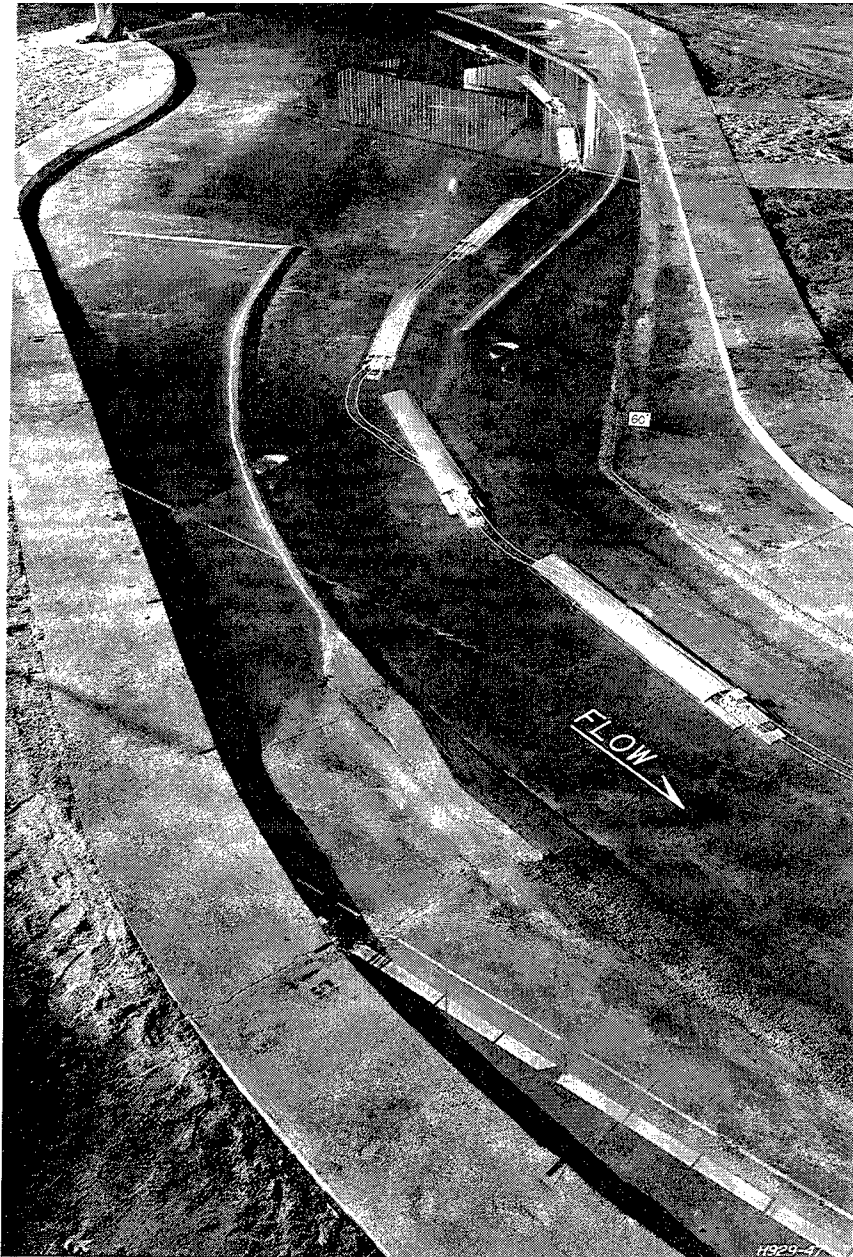
Photo 6. Plan B, looking upstream, discharge 60,000 cfs. Path of upbound tow leaving Piermont cutoff. Note maneuvering near end of Bull Revetment

No major difficulties were indicated for upbound tows navigating through the bendway, but it should be noted that considerable maneuvering was required to move through the constriction at the upstream entrance to Piermont cutoff because of the alignment of currents through this reach (Photo 6).

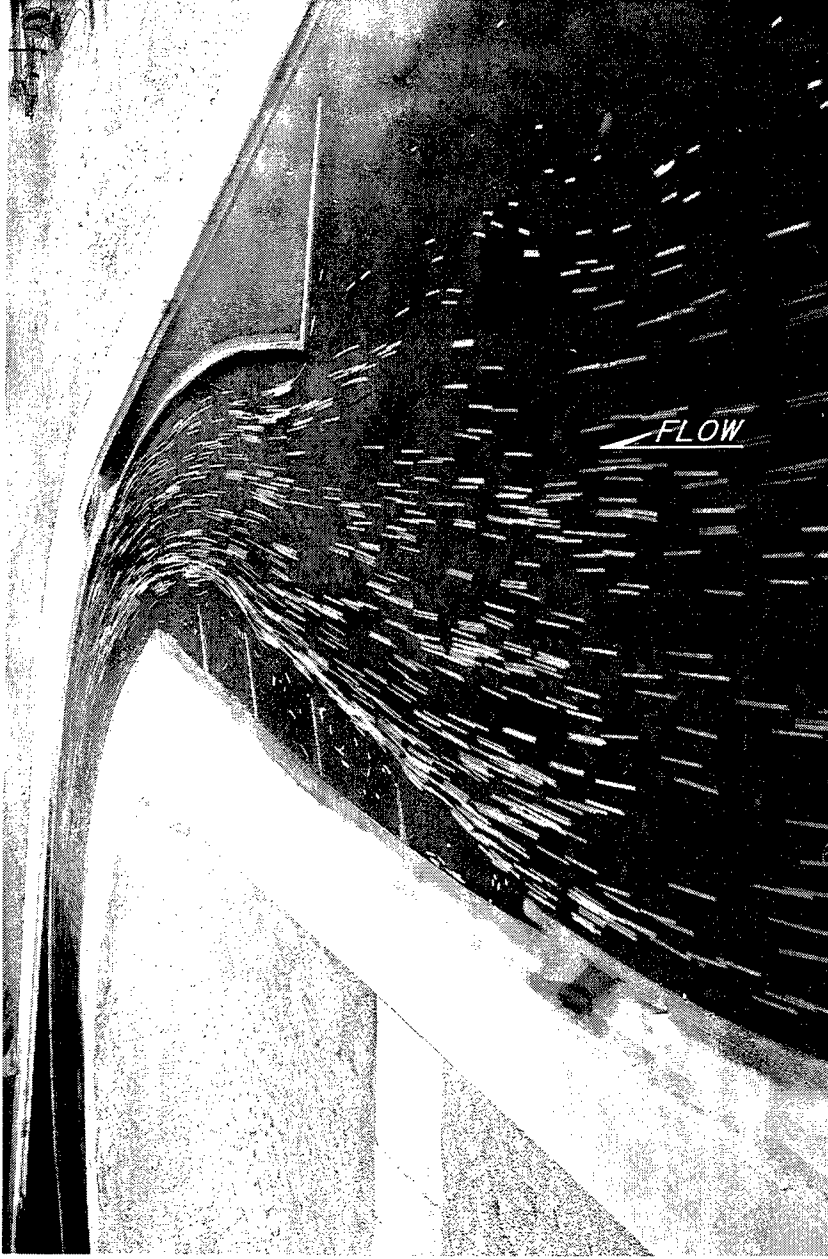
Photo 11. Plan C, looking downstream, discharge 80,000 cfs. Confetti showing surface current patterns entering and through Piermont cutoff

to 9.1 fps with riverflows of 20,000 and 134,000 cfs, respectively. In this reach, a reduction in the maximum velocity of the current of about 2.0 fps was observed when compared to Plan B. There was very little difference in current alignment and velocities through the cutoff. The flow appears to be more uniformly distributed at the upstream entrance to the cutoff; however, the flow was still concentrated toward and along the right descending bank of the bendway (Photo 11).

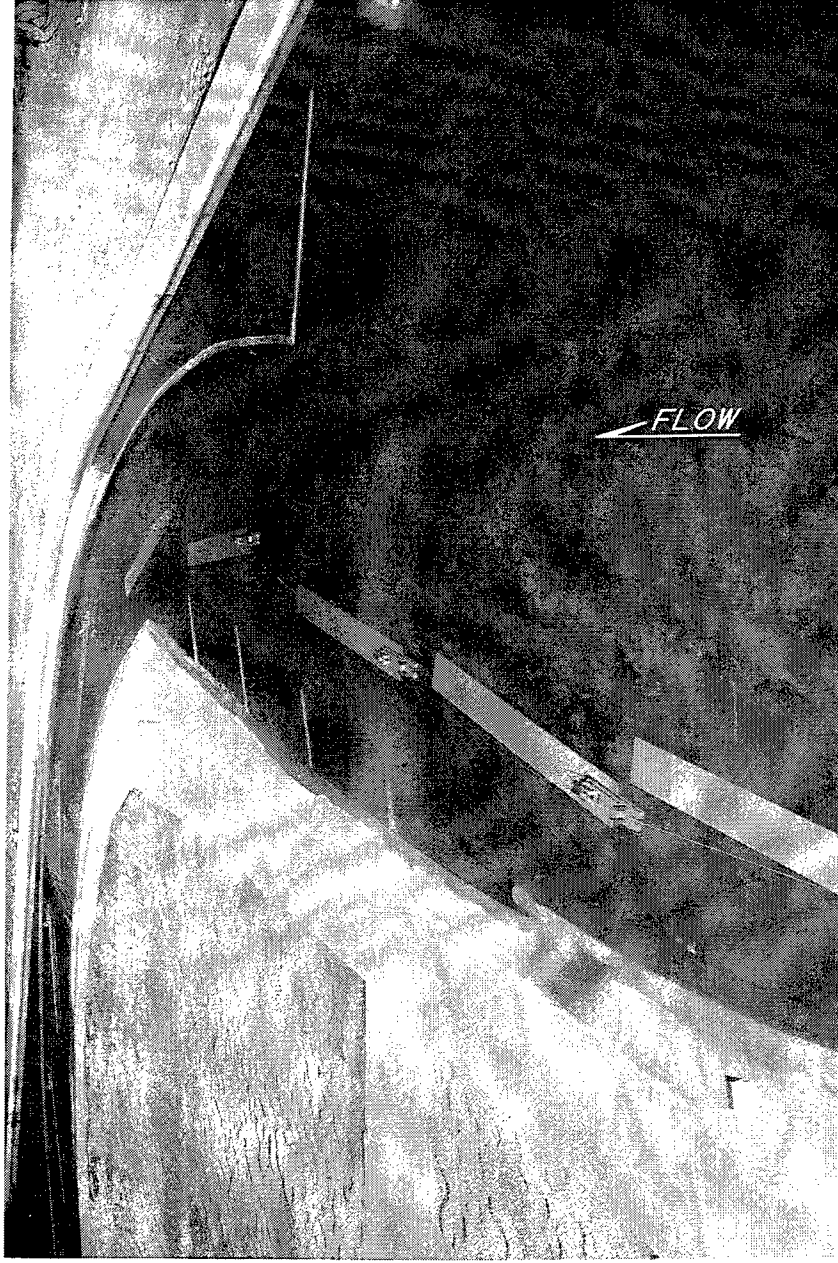
Photo 12. Plan C, looking downstream, discharge 60,000 cfs. Path of downbound tow driving past four spur dikes and into Piermont cutoff

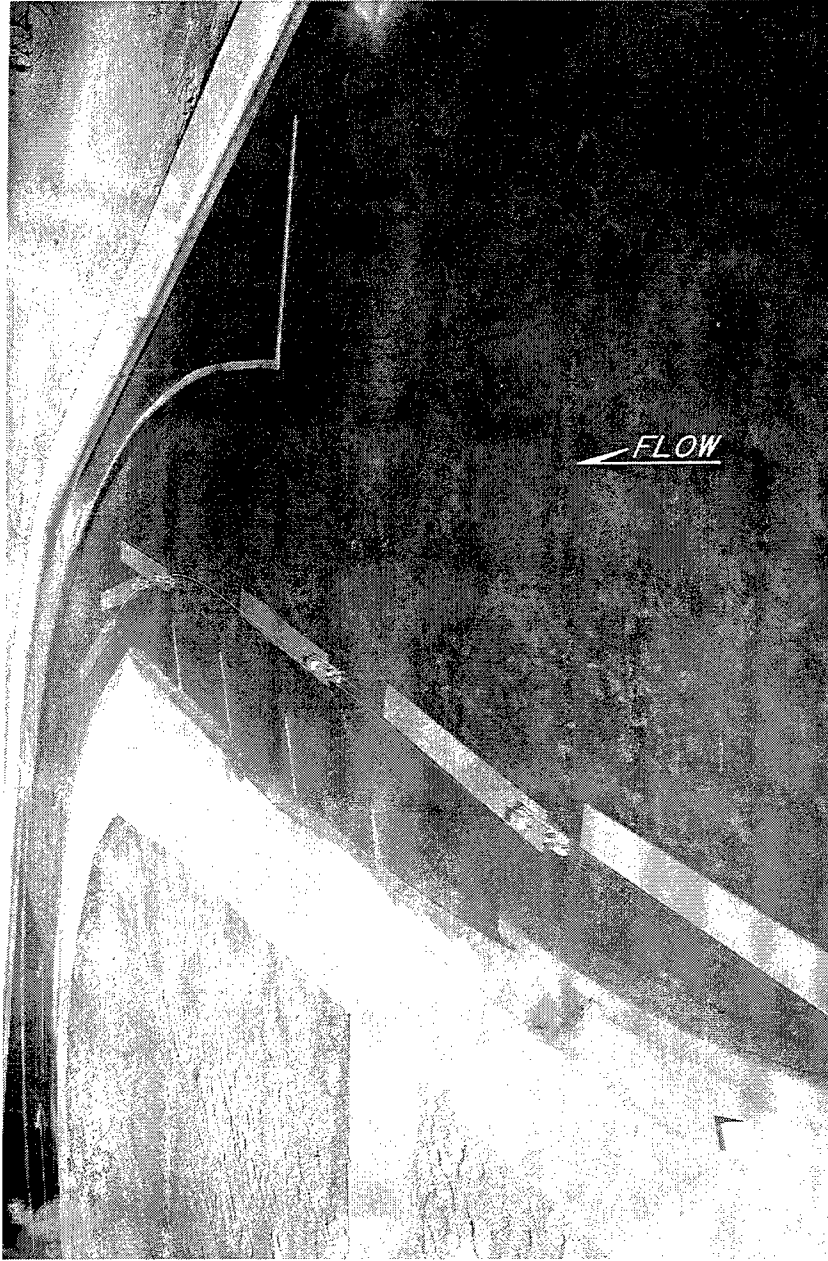
Photo 13. Plan C, looking downstream, discharge 80,000 cfs. Path of downbound tow flanking past four spur dikes and into Piermont cutoff. Note that tow is positioned to inside of bend

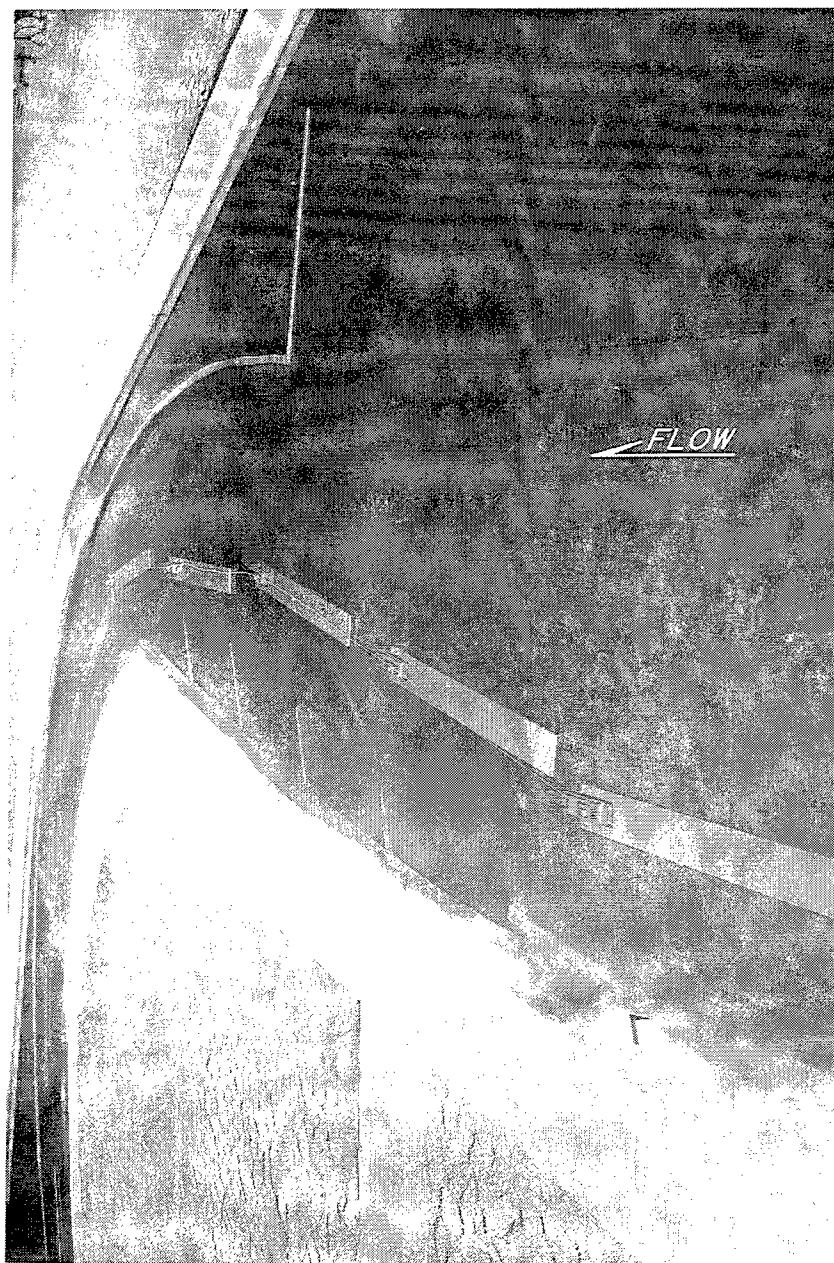
Photo 14. Plan C, looking downstream, discharge 80,000 cfs. Path of upbound tow leaving Piermont cutoff

Navigation conditions for upbound tows navigating Piermont cutoff were satisfactory with all riverflows. However, it should be noted that some maneuvering was required at the upstream entrance of the cutoff (Photo 14).

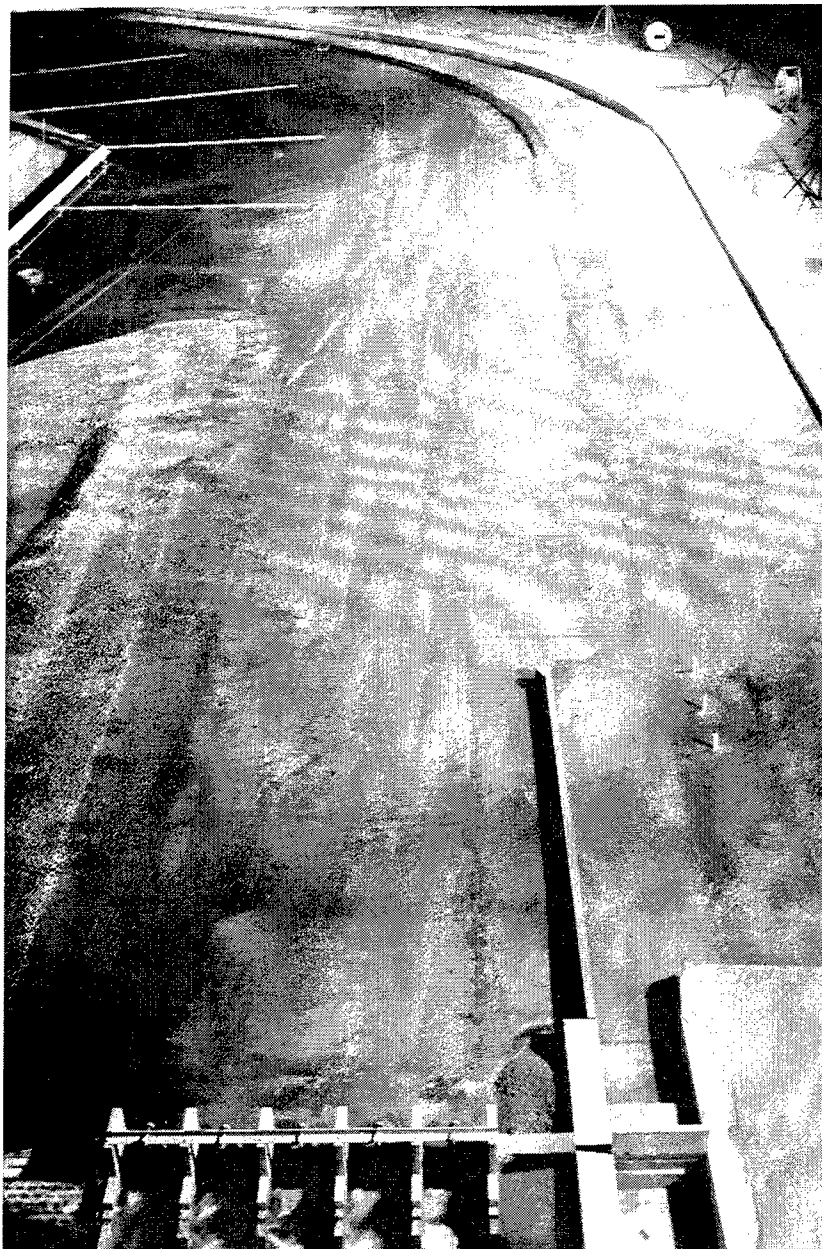
Photo 24. Plan D, looking upstream, showing the upper lock approach

Plan D, shown in Figures 11 and 12 and Photos 23-25, consists of the following principal features:

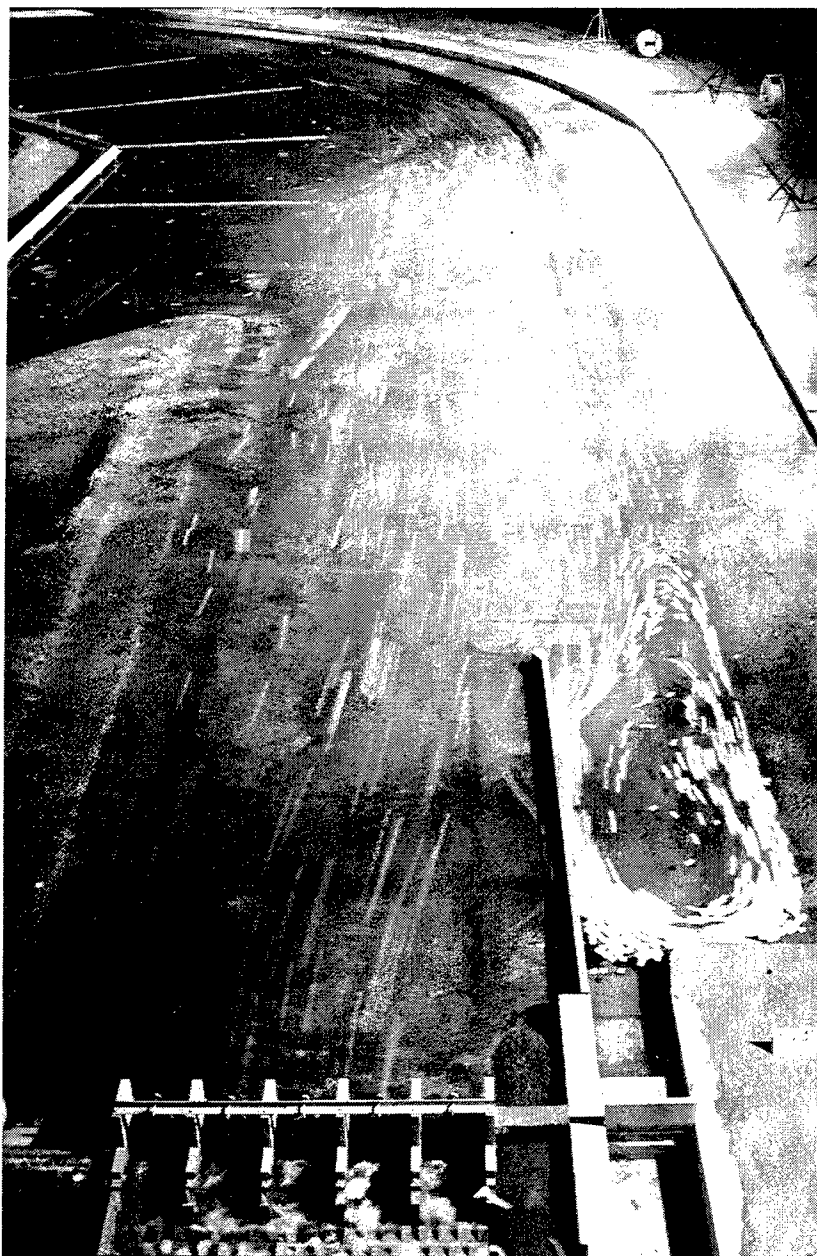
Photo 27. Plan D, looking upstream, discharge 134,000 cfs. Confetti showing surface current patterns. Note large eddy landward of guard wall

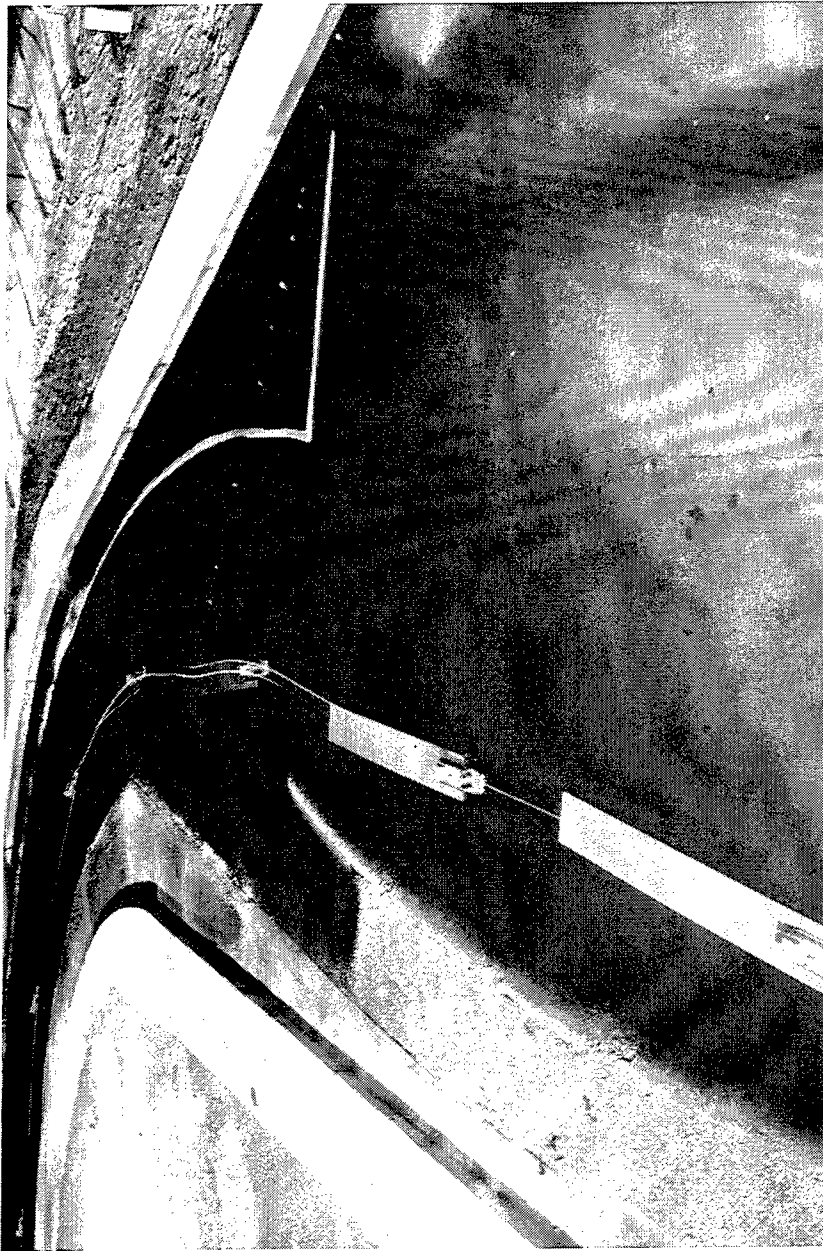
Photo 30. Plan D, looking downstream, discharge 80,000 cfs. Path of downbound tow flanking past Bull Revetment and into Piermont cutoff. Note tendency for currents to move toward left bank in vicinity of Piermont cutoff

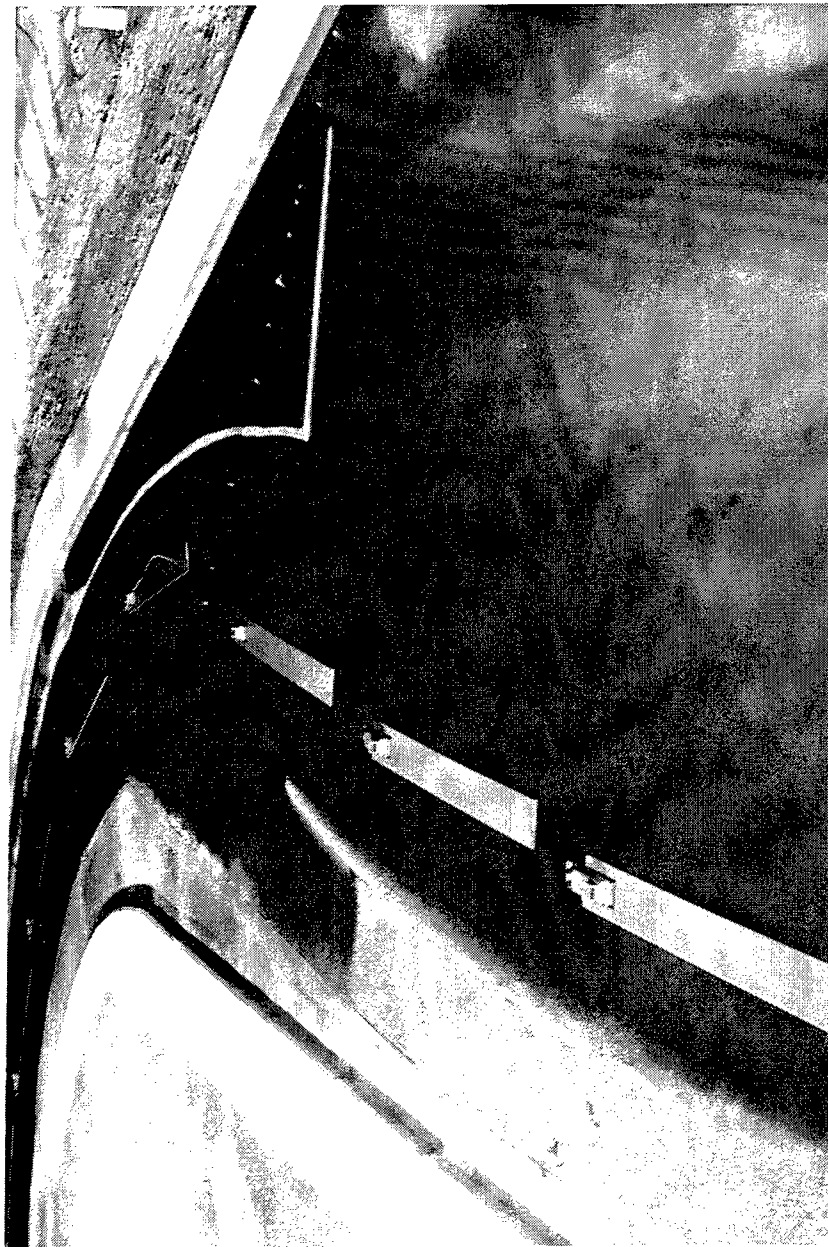
Photo 32. Plan D, looking downstream, discharge 80,000 cfs. Path of upbound tow leaving Piermont cutoff and moving past Bull Revetment. Note tendency for tow to be moved toward Bull Revetment

Navigation conditions were also difficult for upbound tows in this reach of the model. The high-velocity currents moving across the dike and the currents deflected off the right bank revetment tended to move upbound tows from midchannel toward Bull Revetment (Photo 32). Upbound tows leaving Piermont cutoff and moving upstream over the submerged portion of Bull Revetment experienced a very strong tendency to be moved toward or into Bull Revetment. An underpowered tow could experience serious navigation difficulty in this reach of the study.

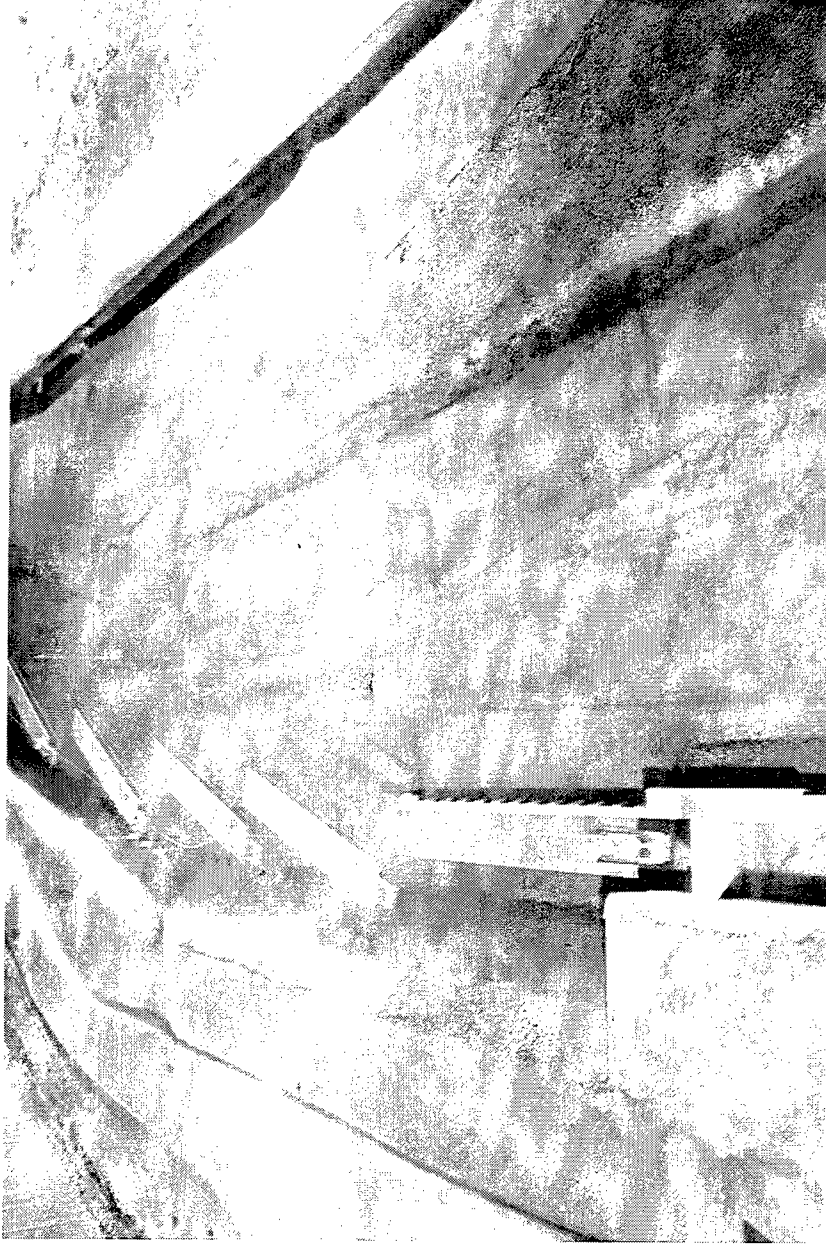
Photo 35. Plan D, looking downstream, discharge 80,000 cfs. Path of downbound tow leaving the lower lock approach. Note tendency for currents to move toward left bank and into mooring dolphins

Navigation conditions were unsatisfactory for downbound tows leaving the lower lock approach with all flows. Downbound tows leaving the lock were pushed toward or into the left bank by the flow moving across the lower lock approach (Photo 35). The mooring dolphins located about 1,000 ft downstream

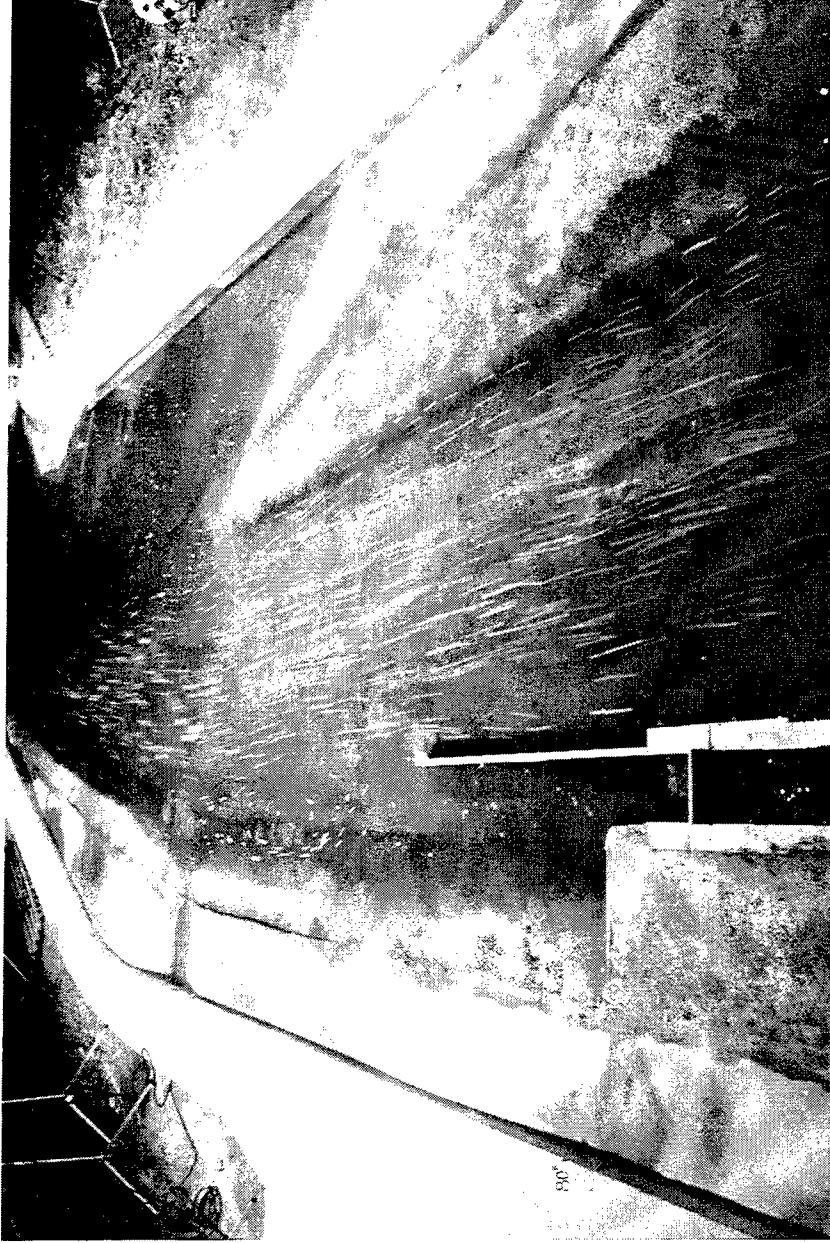
Photo 38. Plan D-2, looking downstream, discharge 80,000 cfs. Confetti showing surface current patterns

Current direction and velocity data are shown in Plates 29-33, and surface current patterns are shown in Photo 38. Current direction and velocity data indicate a 5 to 10 percent reduction in the velocity of the current in the excavated channel. The flow was more evenly distributed across the excavated channel than with Plan D-1. The intensity of the eddy in the lower lock approach was also reduced. The maximum current velocity recorded across the lower lock approach was about 5.0 fps with a riverflow of 100,000 cfs. The maximum upstream current velocity in the eddy in the lower lock approach was about 2.0 fps with a riverflow of 100,000 cfs.
